Staff Report (ID # 11098)

Summary Title: 411 Lytton Avenue Study Session

**411 LYTTON AVENUE
PALO ALTO, CALIFORNIA
HISTORIC STRUCTURE REPORT**

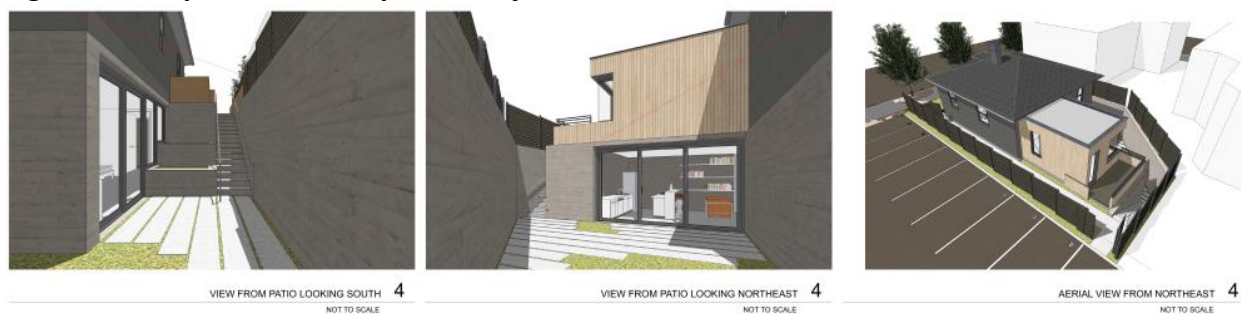
Figure 1: Perspectives of Proposed Project

The applicant also proposes a 223 square foot addition to the rear of the existing building, and work that would accommodate two new housing units below grade. The existing carport structure would be removed. Excavation would occur underneath the building, and work at the rear of the property would expand the existing half-basement to creating a full basement with a sunken private open space area for the residents. The two studio housing units would contain 478 and 699 square feet of floor area, respectively, within the basement. The rear of the units would have direct access to the sunken private open space area. Three of the four parking spaces would be provided off-site at the adjacent 437 Lytton Avenue property.

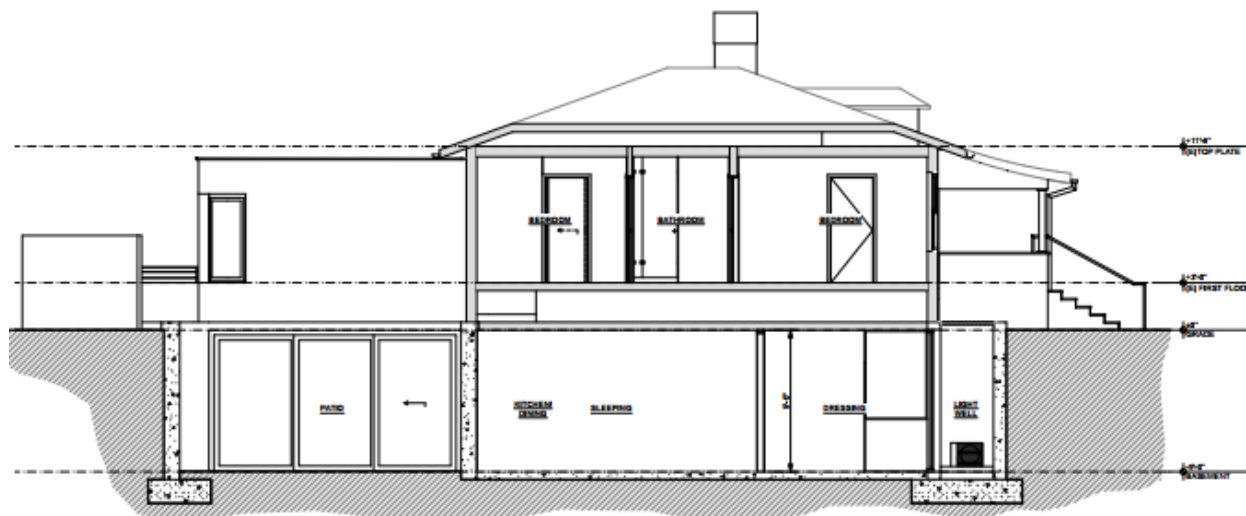
Figure 2: Cross Section of Proposed Project

The proposed project converts the unimproved half-basement to a full basement accommodating two new residential units. The new exterior basement wall is of board-formed concrete, consistent with the existing concrete foundation. The two-level rear addition is set back half the width of the existing residence. The ground-floor (second) level of the addition is faced with stained wood siding, compatible with the painted wood shingles of the original structure. The basement level also uses the board-formed concrete. New doors and windows in the basement level are simple and of painted aluminum, differentiating them from, but compatible with, the historic windows. The roof is flat, with the parapet at the same height as the wall height of the original structure. The character-defining architectural features of the original structure are not impacted.

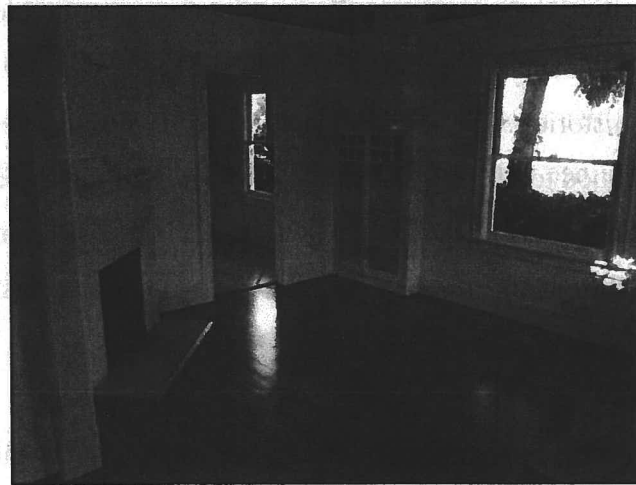
The interior plan for the house includes a living room accessed from the front entrance, a kitchen to the rear and behind the living room and two bedrooms to the west of the living room. Wood floors finish the living room and bedrooms. Room entrances feature original wood surrounds. The living room features an original fireplace and one original built-in cabinet (**Figure 11**).

Figure 11. Original fireplace and built-in cabinet in living room (Photo: PAST Consultants).

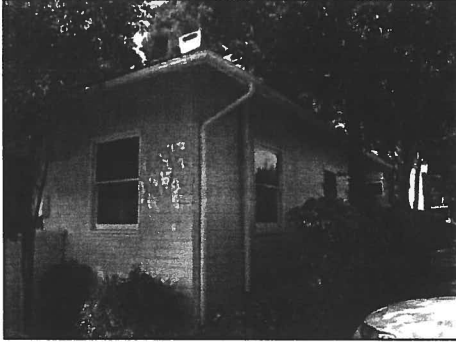
<p>Figure 13. Wood shingle exterior wall cladding (Photo: PAST Consultants).</p>
<p>3. Hipped roof with Craftsman-style overhanging eaves and exposed rafter tails in primary roof and dormer roof (Figure 14).</p>

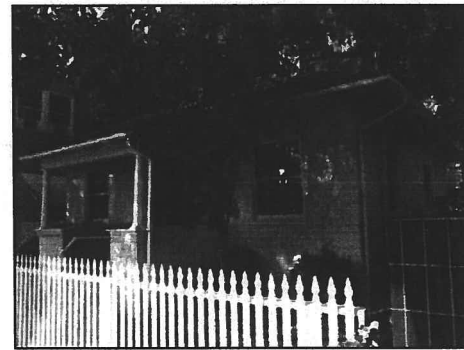
5. One-over-one, double-hung sash windows (Figure 16).

Figure 16. One-over-one, double-hung sash windows on Lytton Avenue facade (Photo: PAST Consultants).

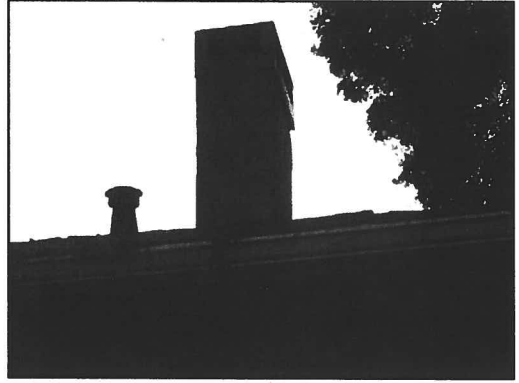
1. Central chimney, now encased in stucco
(Figure 17).

Figure 17. Original chimney now covered with stucco
(Photo: PAST Consultants).

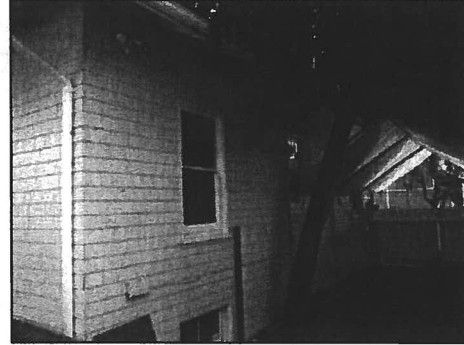
1. One-over-one, double-hung sash windows on non-primary facades (**Figure 18**).

Figure 18. One-over-one, double-hung sash windows on driveway facade (*Photo: PAST Consultants*).

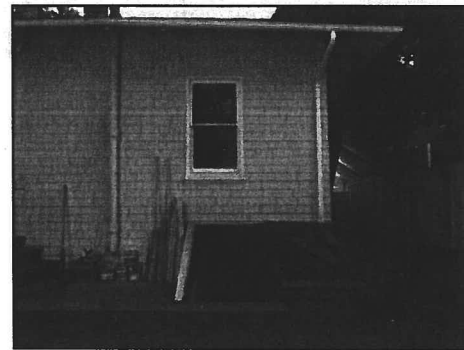
2. Entrance to half-basement on rear facade (**Figure 19**).

Figure 19. Entrance doors to half-basement (*Photo: PAST Consultants*).

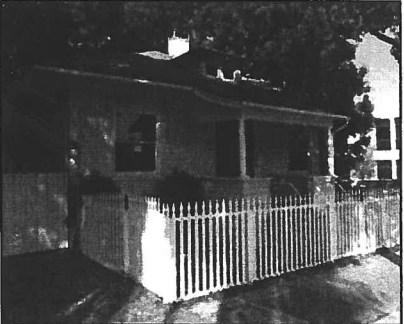
<p>1. Newer site fencing along Lytton Avenue and in front of the driveway (Figure 21).</p>

<p>Figure 21. Newer site fencing along Lytton Avenue (Photo: PAST Consultants).</p>
<p>2. Replaced asphalt shingle roofing on primary and dormer roofs (Figure 22).</p>

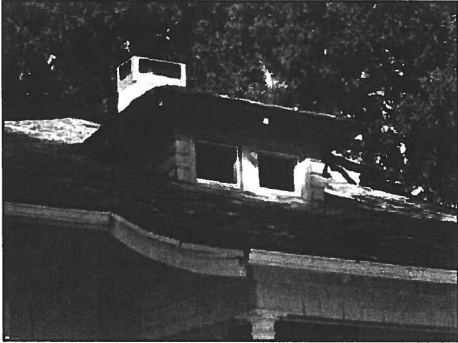
<p>Figure 22. Replaced asphalt roofing on primary roof and dormer (Photo: PAST Consultants).</p>
<p>3. Steel pipe railing added to front porch (Figure 23).</p>

- Remove asphalt roofing on primary and dormer roof surfaces. Inspect roof underlayment and roof structure for any signs of deterioration. Replace underlayment or individual structural members as necessary.

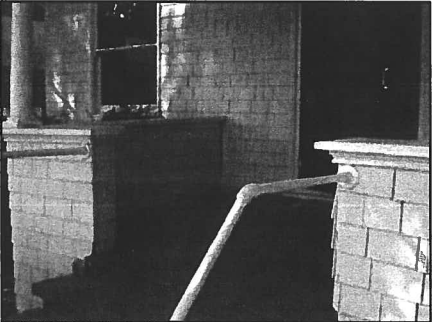
<p>Figure 23. Steel pipe railing added to front porch (Photo: PAST Consultants).</p>

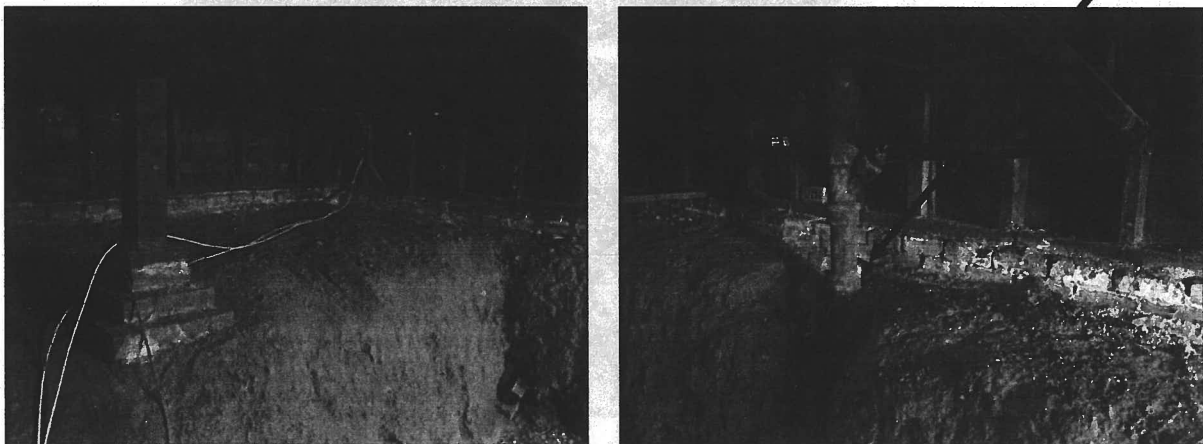
Access to the foundation is through a pair of wood doors that lead down to a half basement. The foundation support consists of what is likely the original brick crib walls and footings. The brick footings and crib walls display mortar loss and significant efflorescence on the individual bricks. Wood sill plates are not tied to the foundation (**Figures 24 and 25**).

Figures 24 and 25. Views of the foundation from inside the half-basement. Brick piers and timber posts are visible in the left image. The right image shows loose bricks and efflorescence at the crib wall, particularly where the sanitary utility line meets the foundation (*Photo: PAST Consultants*).

- Perform structural engineering assessment of building foundation and settlement of front porch.
- Based on the engineering assessment, repair the foundation, if necessary.

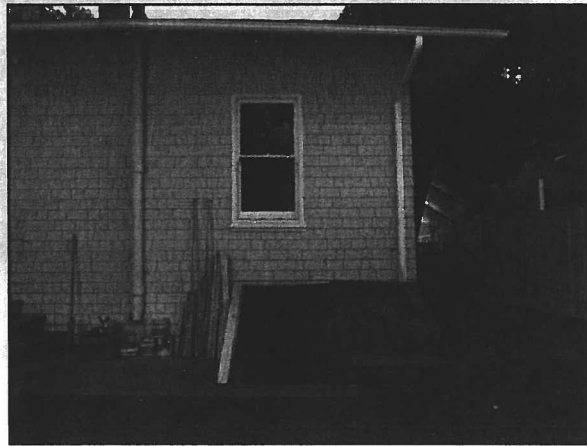
As shown in **Figure 27** above, the replacement asphalt shingles are in poor condition. Replacement gutters and downspouts are misaligned at various locations, particularly on the front façade of the house. Downspouts discharge water against the house and contribute to the deterioration of the foundation (**Figure 28**).

Figure 28. Downspouts discharge water against the building, shown by an arrow (*Photo: PAST Consultants*).

- Install replacement roof surfaces.
- Repair and/or replace gutters and downspouts, as necessary. Extend downspouts to drain water away from building walls.

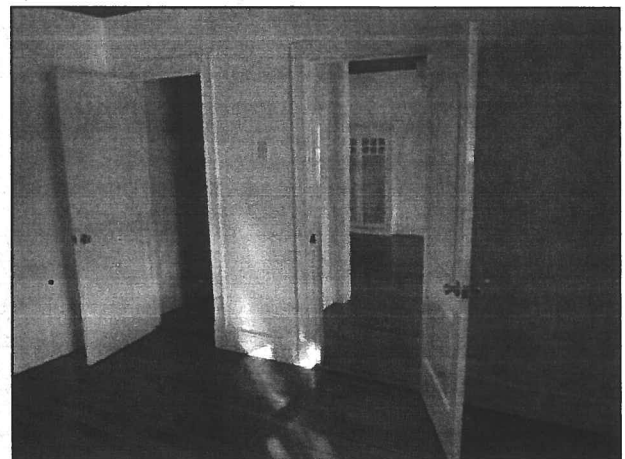
The interior is in good condition and retains much of its original features, including wood floors, door surrounds and wainscoting boards in the kitchen. The living room displays an original fireplace and built-in cabinet (**Figures 31 and 32**).

Figures 31 and 32. Original finishes and features in the living room (left) and front bedroom (right). (*Photos: PAST Consultants*).
