Historic Resources Board

Staff Report (ID # 12015)

Summary Title: 819 Ramona Street (Zion Church)

Title: PUBLIC HEARING / QUASI-JUDICIAL. 819 Ramona Street [21PLN-00015]: Request for Historic Resources Board Review of a Minor Architectural Review Application for Consistency with the Secretary of the Interior's Standards. The Project Includes the Installation of a New Ridge Skylight and Four New Windows at the Rear Elevation at the AME Zion Church, Classified as a Local Historic Resource Category III, and listed on the California Register of Historical Resources and deemed eligible for the National Register of Historic Places. Zone District: AMF (MUO). Environmental Assessment: Exempt from the California Environmental Quality Act per Sections 15331 (Historical Resource Rehabilitation). For More Information Contact the Project Planner Danielle Condit at danielle.condit@cityofpaloalto.org.

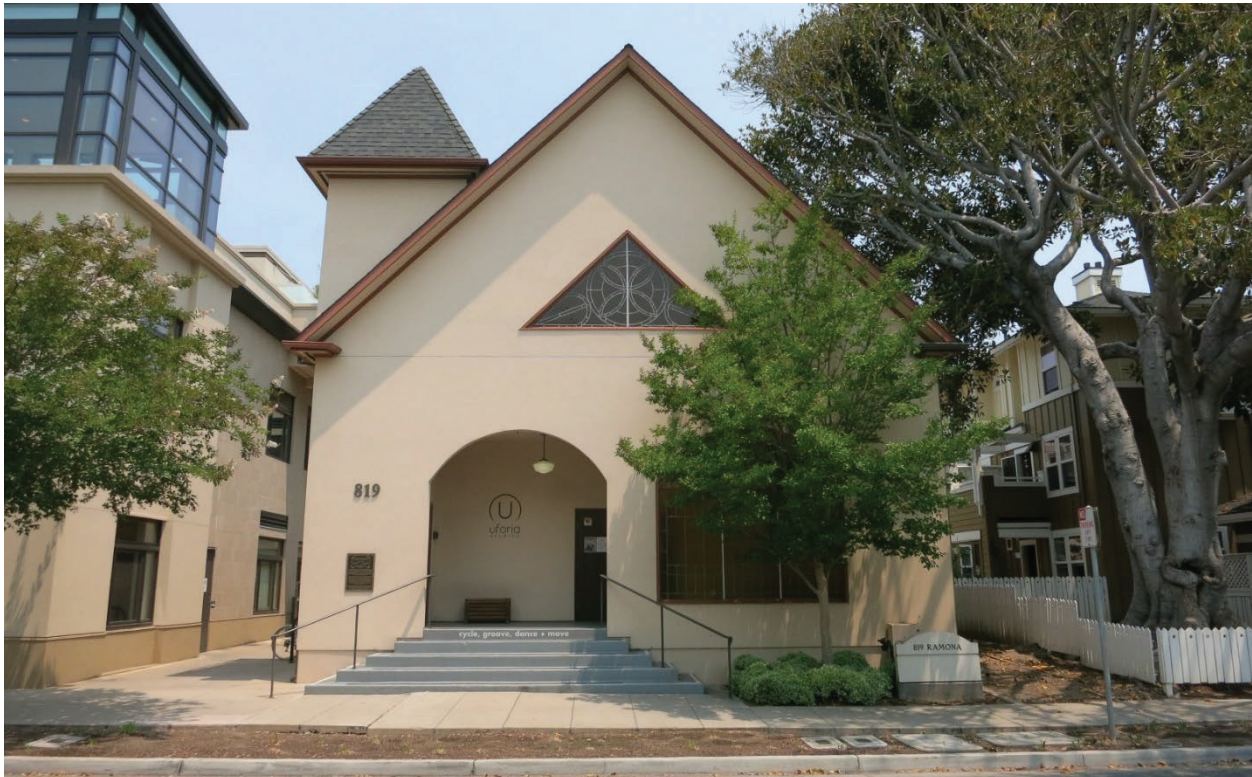
Figure 2: Primary (west) façade of the subject building. Looking east.

- Freestanding, symmetrical one-and-a-half-story volume (**Figure 2**)

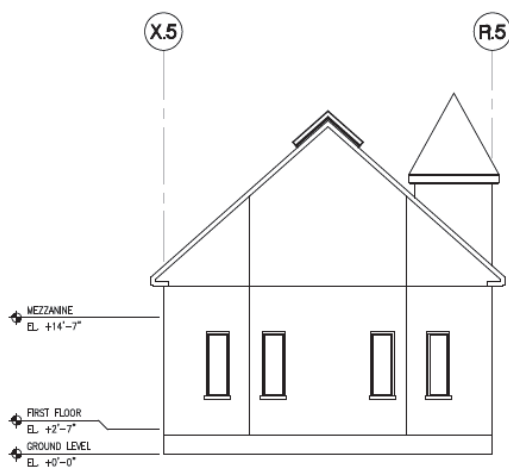
Figure 3: Proposed east (rear) elevation.

The four windows that are proposed to be installed at the east façade will be approximately 2'-6" wide and 7'-0" high and will be arranged in pairs along the rear wall of the building (**Figure 3 and Figure 4**). Unlike the existing historic windows, the proposed windows will be fixed sash with clear glass to allow more light into the building and to differentiate the new windows from the historic leaded amber glass windows. As stated earlier, the proposed new windows are located along a rear façade, facing an adjacent building over a paved areaway, and will not be visible from the public right-of-way.

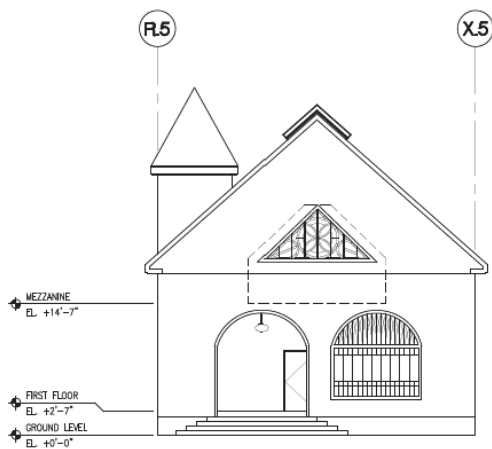
Figure 5: Proposed west elevation (primary façade).

While the cladding material of the roof is not original, the form, massing, and pitch of the roof is a character-defining feature of the building. The proposed skylight will retain these features to a high degree as it follows the form and massing of the roofline, and it will not change its overall design, form, or pitch. The skylight itself will cause a height increase of approximately 9" to accommodate its framing and waterproofing.

This feature will be visible from the public right-of-way when viewed from a strong oblique angle. Due to the presence of an adjacent building to the north (along Ramona Street), and due to the

relatively narrow width of Ramona Street, the skylight is only partially visible when seen from the north, and somewhat more visible when seen from the south (looking away from Channing Avenue).

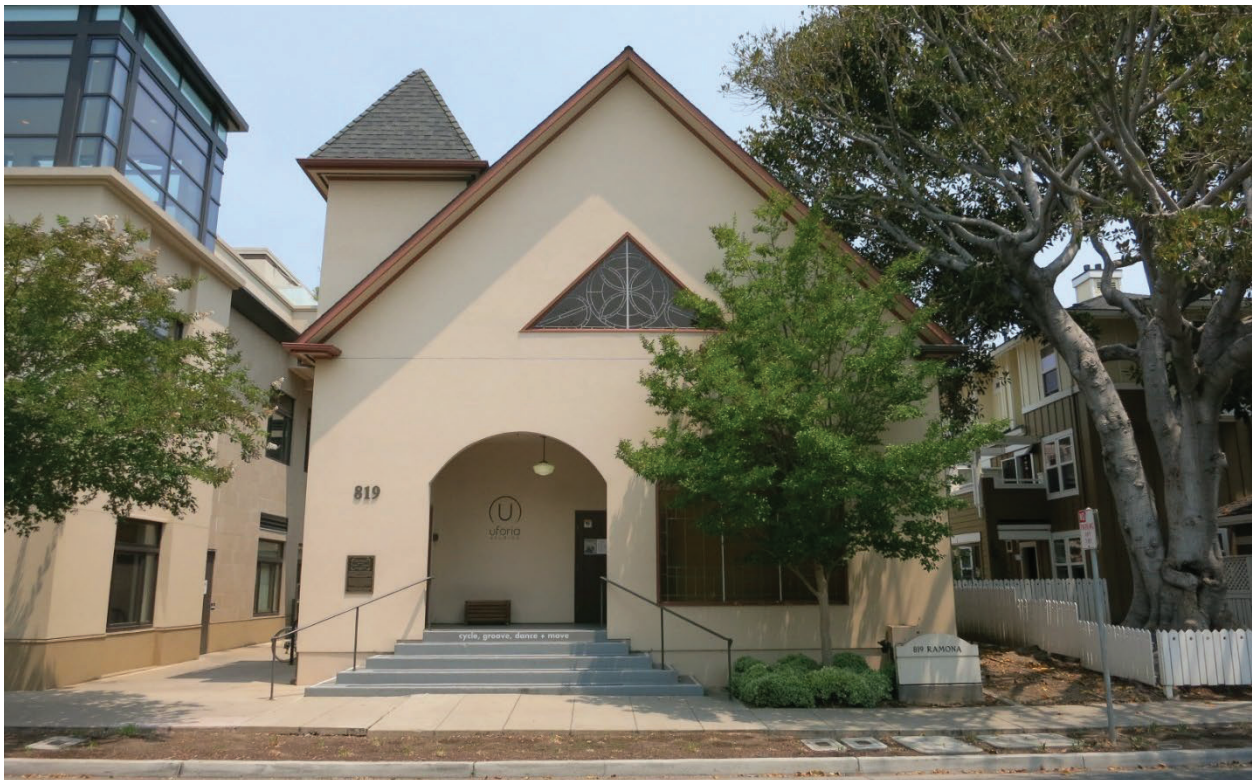
Figure 2: Primary façade of the subject building. Looking north.

The primary (south) façade, facing Ramona Street, features a smooth stucco façade, a slightly projecting molded cornice with a cornice return, and symmetrically placed openings that include a triangle-shaped, fixed, leaded glass window within the gable peak, a segmental arched window with multi-lite fixed leaded glass at the east side of the first floor, and a segmental arched entrance at the west side of the first floor.⁶ This entrance leads to an open porch with double doors leading to the interior space. The entrance is reached by a series of low concrete steps with metal handrails. A metal plaque containing information about the building's history is located to the west of the entrance.

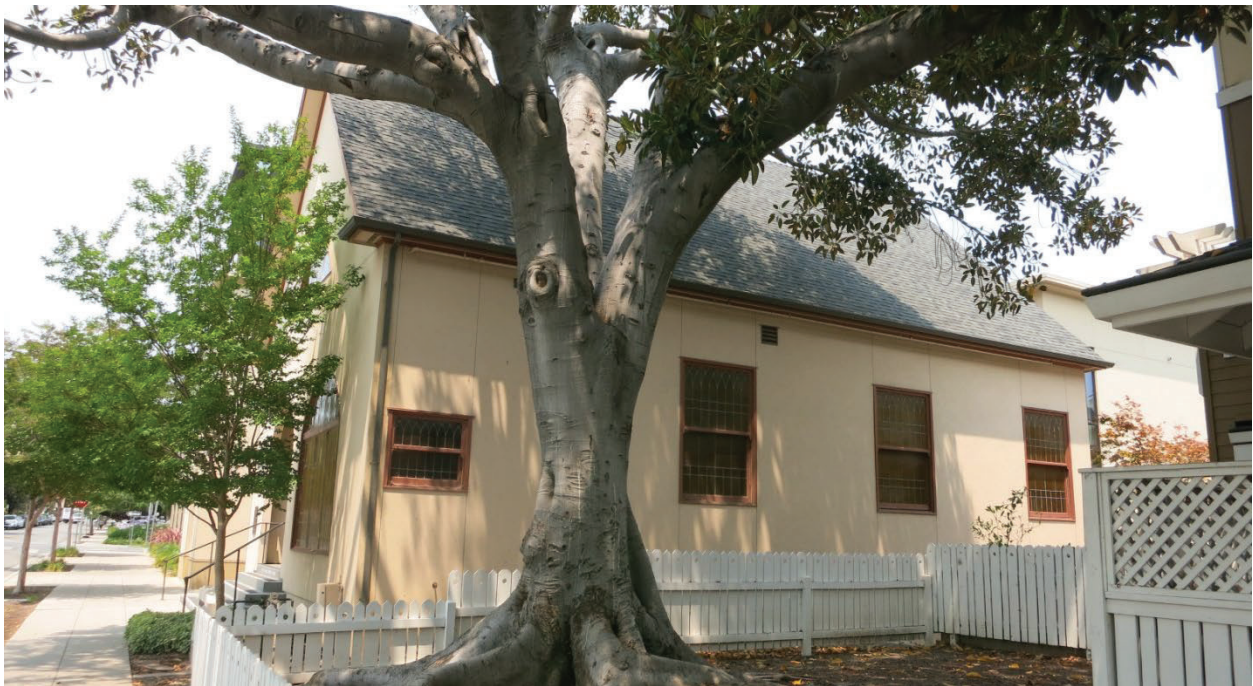
Figure 3: East façade of the subject building. Looking west.

The east façade features four double-hung leaded glass windows. A small typical window is located on the south side of the façade (towards Ramona Street), while the other three typical windows are larger in size (**Figure 3 and Figure 4**). A flight of concrete stairs with metal handrails leads to a below-grade basement entrance with a single-leaf fully glazed door with transom and a fixed window (**Figure 5**).

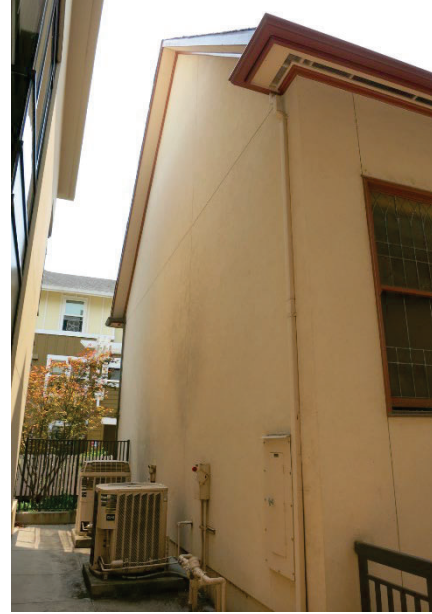
Figure 9: Rear (north) façade of the subject building. Looking southeast.

The rear (south) façade of the subject building consists of a plain stucco wall with no openings and several utility boxes and utility connections, including air conditioning, are located along this façade **(Figure 9)**.

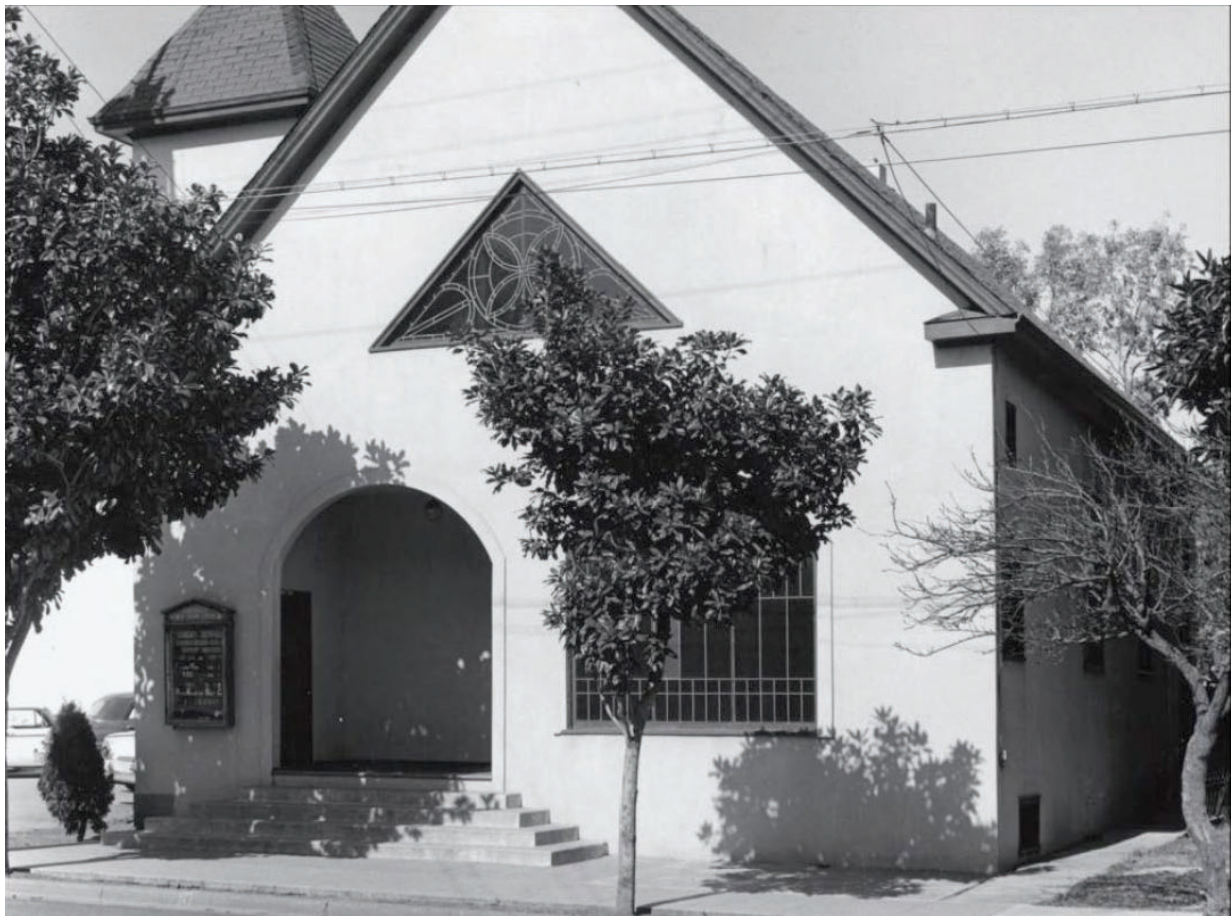
Figure 10: University AME Zion Church in 1964. Source: Palo Alto Historical Association.

The subject building was constructed by a local builder, W.S. Couter, and was completed in 1925.⁷ The building remained the home of the University AME Zion church until the congregation constructed a new church and sold this building in 1965. Photographs of the building in 1964, during its time as the University AME Zion church show that few changes have been made to the building since its erection (**Figure 10 and Figure 11**).
