Arastradero Preserve Trails Management Plan

Prepared for City of Palo Alto
by:

Amphion Environmental, Inc.
&
Thomas Reid Associates

March 2001

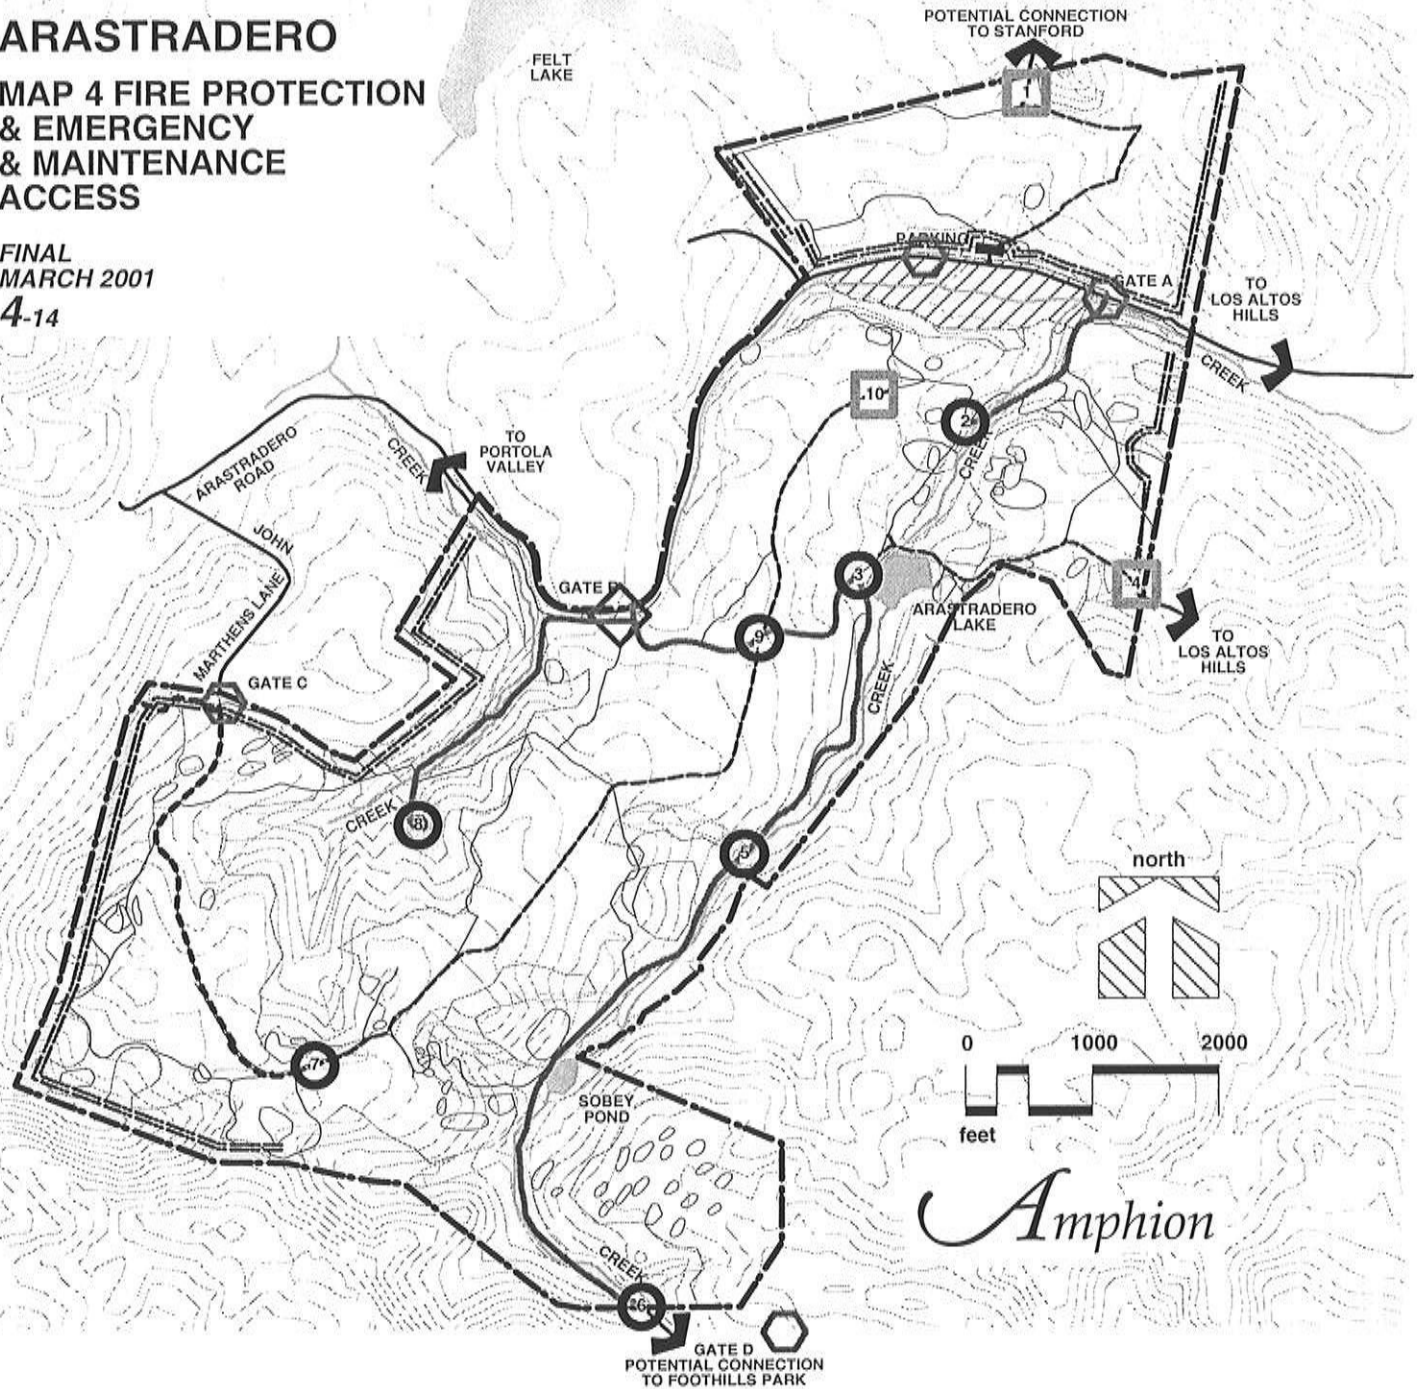
MAP 4 FIRE PROTECTION & EMERGENCY & MAINTENANCE ACCESS

NOTE: TURN AROUND NUMBER 8 HAS A TIGHT TURNING RADIUS & WILL NOT ACCOMMODATE TYPE 3 & 4 VEHICLES

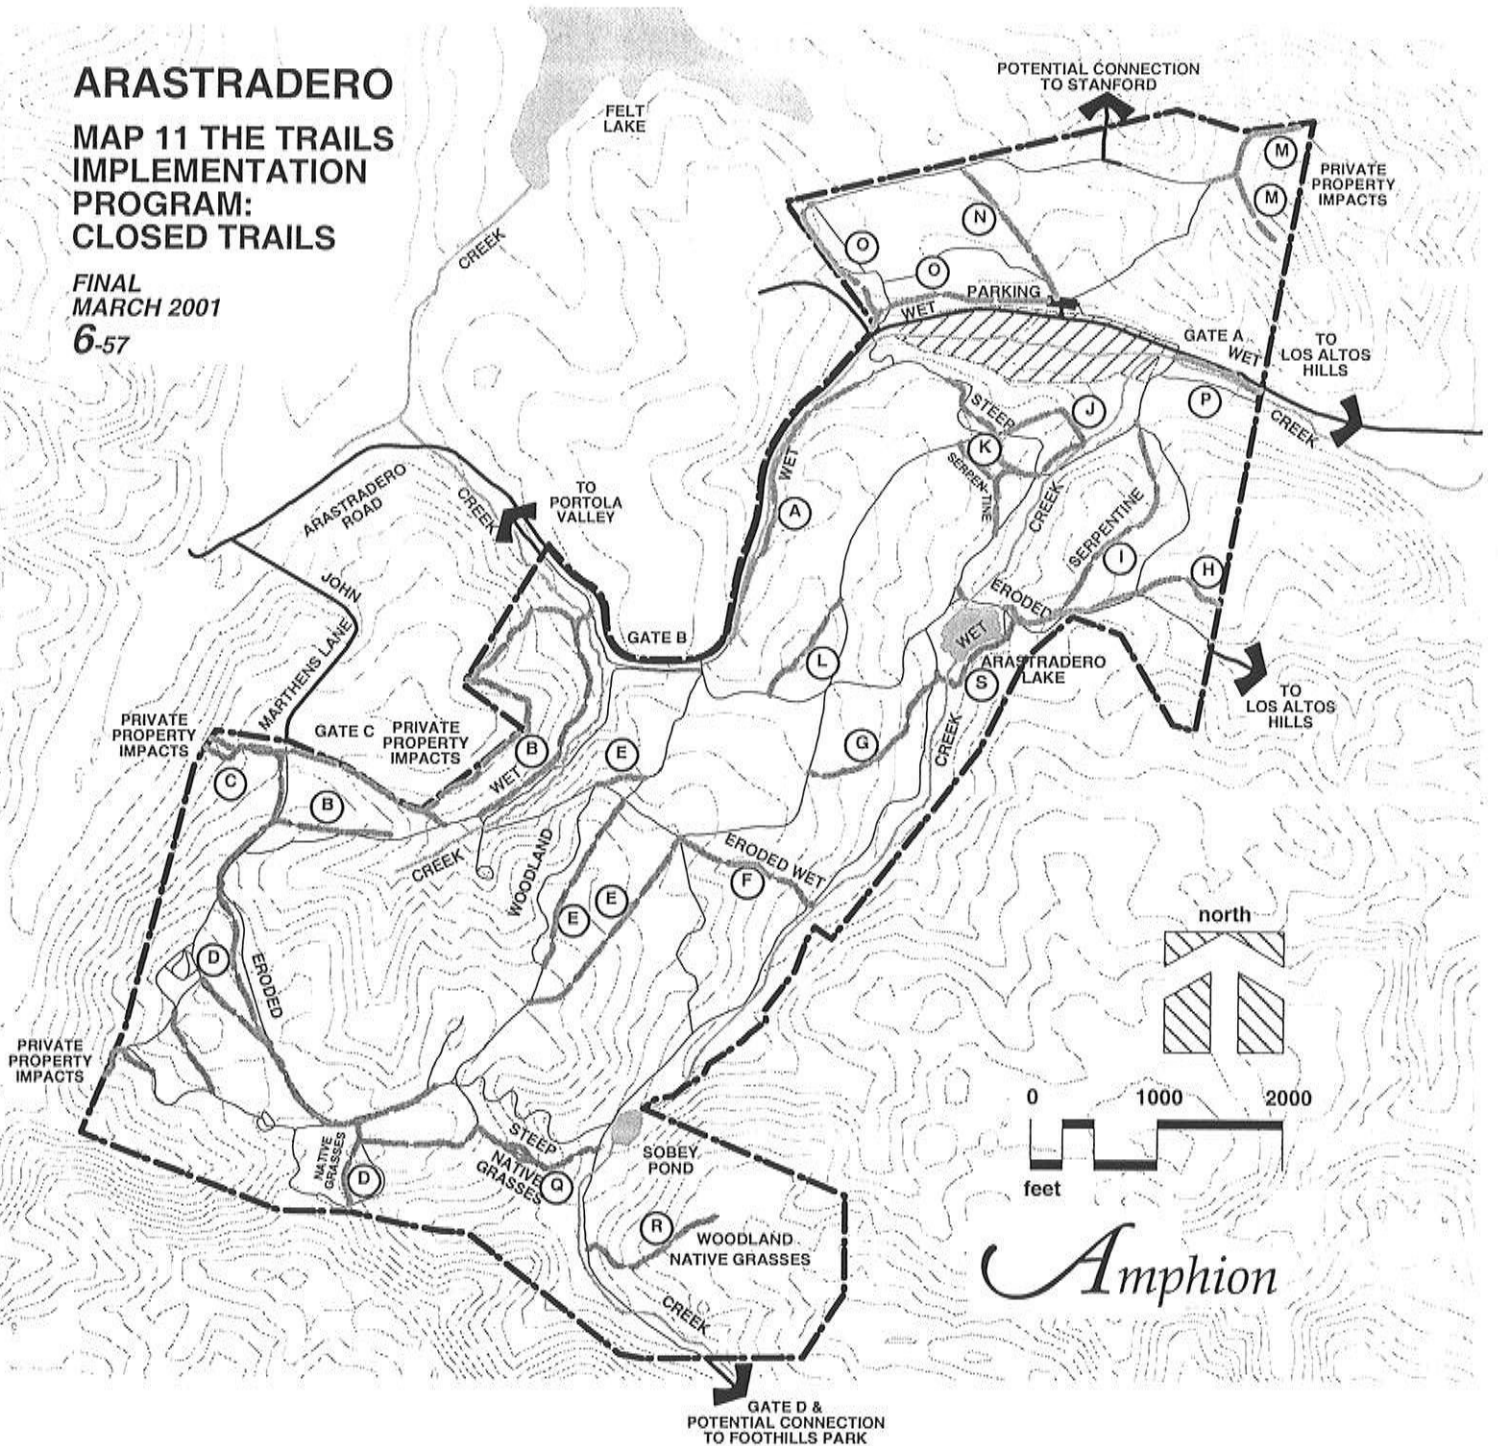
MAP 11 THE TRAILS IMPLEMENTATION PROGRAM: CLOSED TRAILS

TRAIL IMPLEMENTATION PROGRAM: CLOSED TRAILS

These trails are to be closed by repairing environmental degradation and restoring the site to a condition that reflects the natural, native habitat of the immediate area. Where appropriate, a new alignment has been proposed as a High or Moderate Maintenance Trail in an environmentally superior location. The purpose of these new routes is to provide enhanced recreation experiences, while minimizing impacts on sensitive resources over the long term, thereby reducing maintenance requirements. Refer to Map 11 (Section 6) for trail routes that are to be closed or rerouted to protect resources.
