Matadero Creek Sampling Sites @ VA Hospital Diesel Spill Site

Table 1: Summary of Water Quality Samples within the boom containment area for total petroleum hydrocarbons, total petroleum hydrocarbons-diesel (with silica gel cleanup), and BTEX (benzene, toluene, ethylbenzene and xylenes).

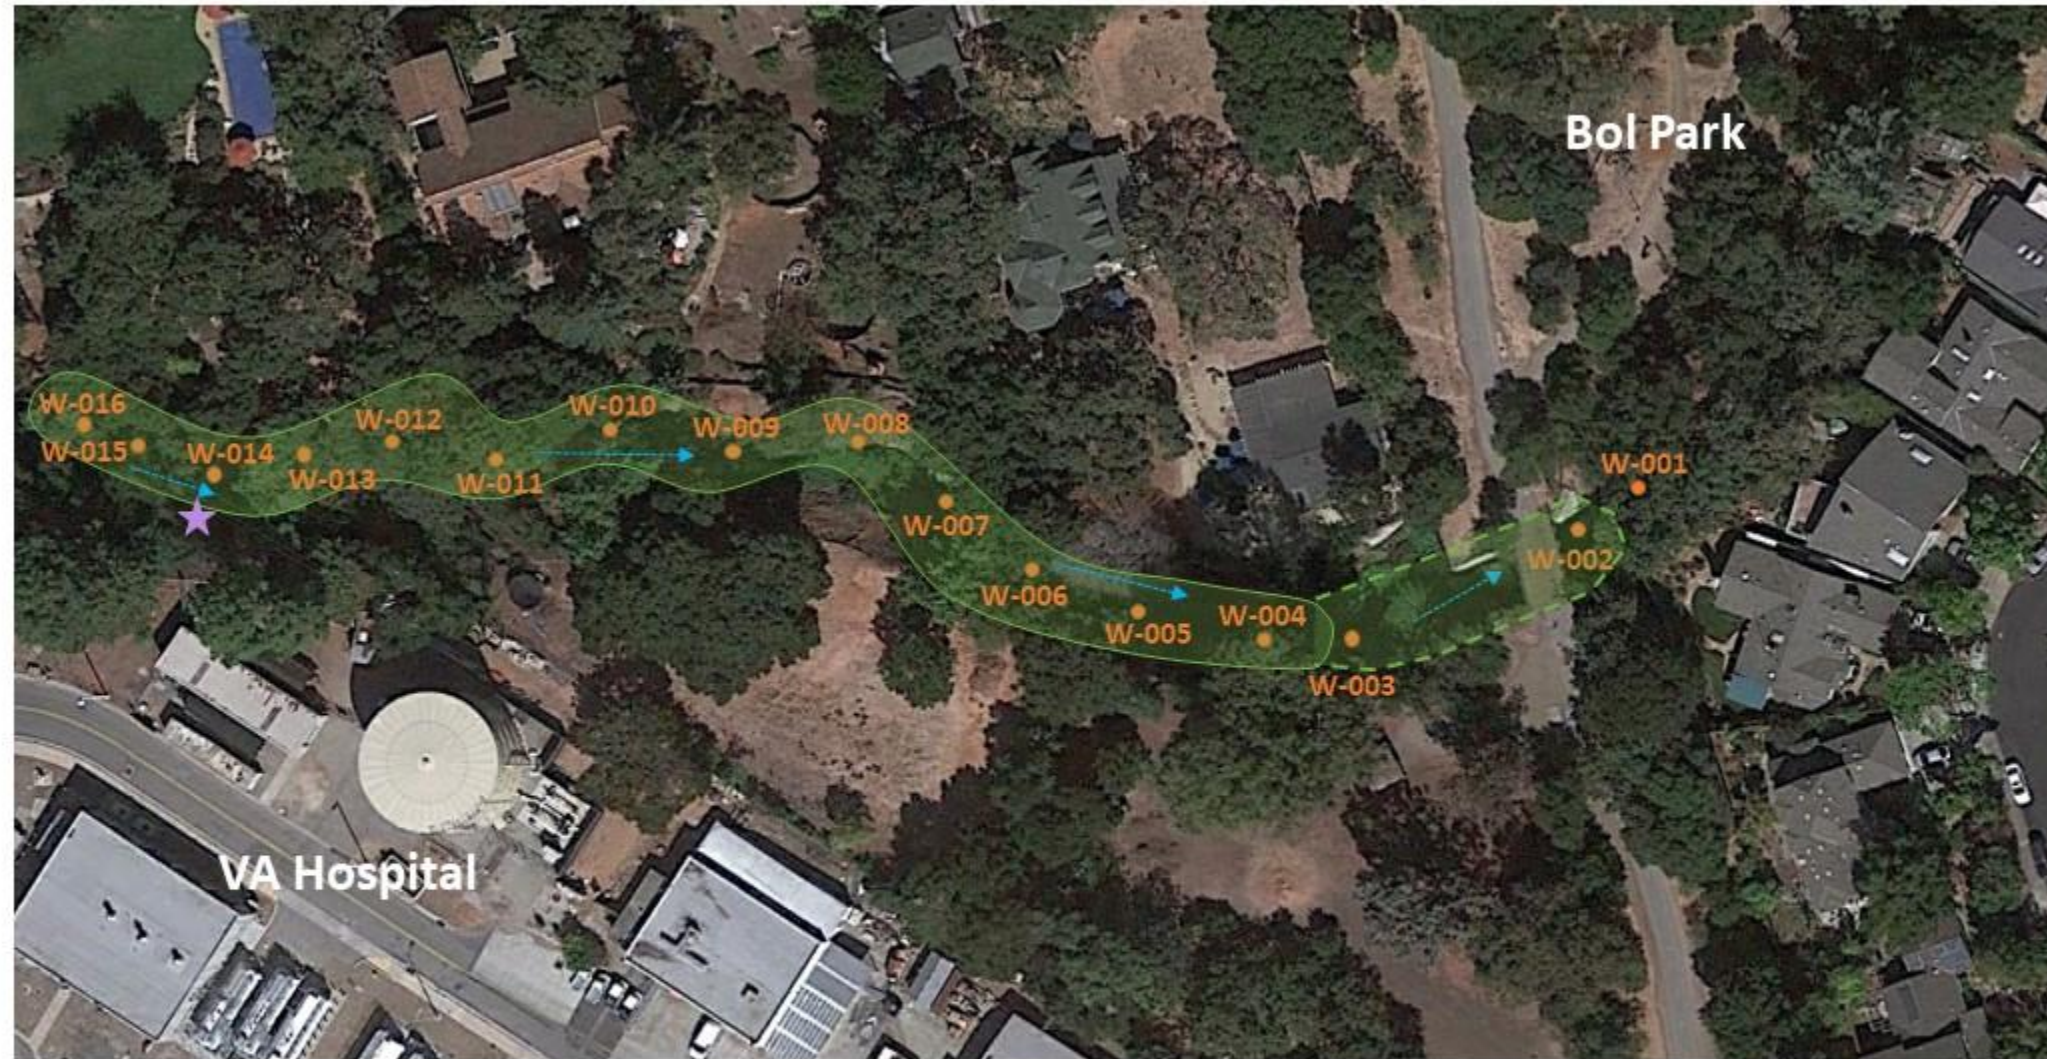
SUMMARY: Data was collected immediately after the spill upstream as a control (point of reference) location (W-016) and downstream of the boom containment area (W-003). Since the release of the data, two more booms were installed upstream of W-003 and upstream of W-002, since it appears that some of the contaminants may be making their way through the containment zone, as indicated in the W-003. In addition, samples were collected within the boom containment area and as anticipated with a diesel spill, the values of Total Petroleum Hydrocarbons-Diesel remain above the water quality habitat goals of 640 micrograms per liter, in four locations. California Department of Fish and Wildlife anticipates that the diesel will naturally attenuate over a timeframe of months; therefore, other clean up alternatives are currently being explored. With the movement of the creek, the booms in place to absorb any remaining fuel products, and the natural degradation of fuel, VA third party experts expect the values to continue on a downward trend. Sampling results have been provided to the City as the VA receives them and results will be released publicly online as they become available.
